## ENVIRONMENTAL WASTE SITE CHARACTERIZATION UTILIZING AERIAL PHOTOGRAPHS AND SATELLITE IMAGERY: THREE SITES IN NEW MEXICO, USA

**Ed Van Eeckhout, Paul Pope, Cheryl Rofer, Naomi Becker, and Bob Wells**

Los Alamos National Laboratory, MS C335, Los Alamos NM 87545 USA

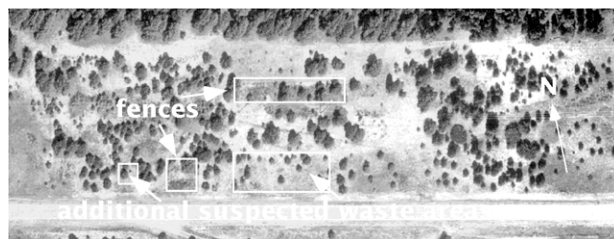
Figure 4(a) shows a 1991 orthophoto of the MDA-F area, with boundaries of suspected trenches overlaid on the photo. Based on these boundaries, a magnetic gradient survey area was defined as

Fig. 4(a). 1991 orthophoto of MDA-F.

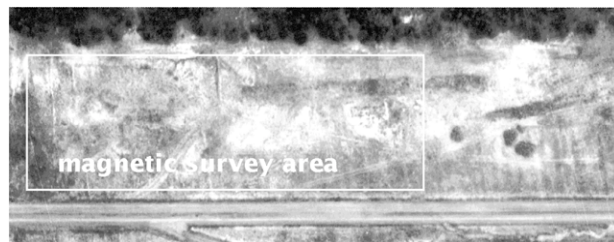
shown on Fig. 4(b), overlaid on a photograph from the 1958 era. Note that the pits and trenches appear to extend beyond the fence lines shown in Fig. 4(a). Because it seemed that the pits and trenches did extend farther than originally thought, a study to evaluate historical photographs of the area was initiated.

Fig. 4(b). 1958 matched photo of MDA-F.

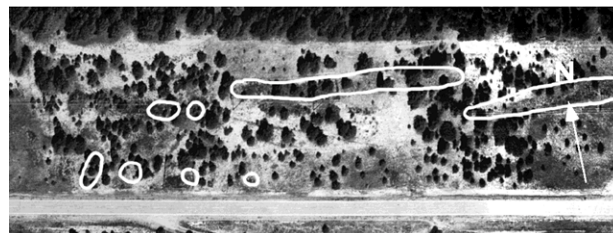
The coregistered images were then imported to a GIS and geographically coded to a common coordinate system. The GIS was used to extract the boundaries of features such as suspected trenches and disturbed soil. The boundaries of disturbed ground, access routes, the main disposal trench, and three other suspected trenches were vectorized from the imagery by on-screen digitizing. These boundaries were overlaid on the most recent image of the site to display the historical characterization features within the context of how the site appears now. This preliminary analysis formed a basis for planning and comparing the results from other surveys of the site. The major trenches found are shown on Fig. 6. Further details of this analysis can be found in Pope et al., 1995.

Fig. 6. Suspected trenches and pits within the area of interest. Note the two large trenches. The one on the right wasn't suspected until the historical photography was inspected.

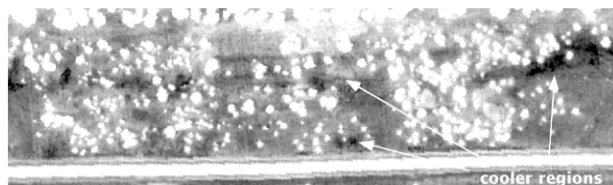
Fig. 7. Thermal imagery over MDA-F. The arrow note some particularly cooler and wetter locations, which partially correspond to pits and trenches.

Figure 7 shows some of the thermal data over MDA-F. The cold and more moist spots are darker in this imagery. In order to verify that, two transects were established across the easternmost pit, as shown in Fig. 8. Both moisture and temperature measurements across these transects indicated differences from the surrounding area. In general, soil moisture content in the trenches were twice as wet as the background and soil temperatures were lower. Figure 9 shows the lowering of

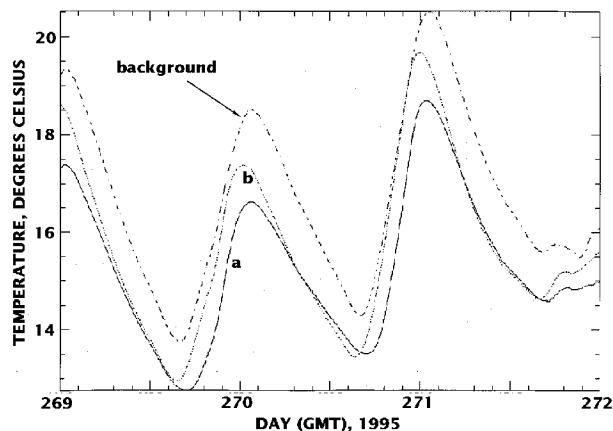
temperatures at a 6 inch depth of burial in the middle of each trench compared to background.

Fig. 9. Comparison of transect a and b temperatures with the background.

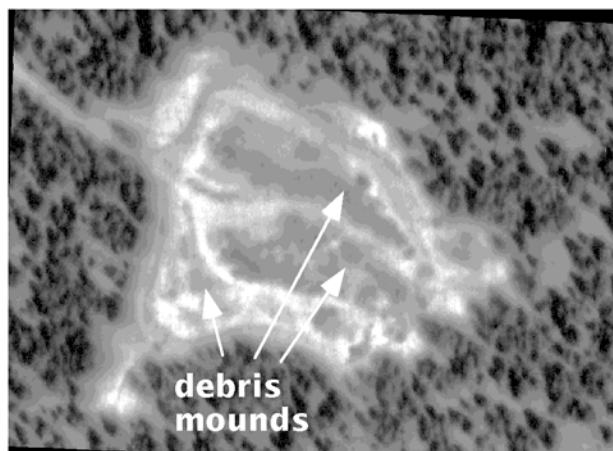
Fig. 10(c). 1951 image of MDA-M area.

Three large east-west oriented mounds of debris are visible in the 1951 image. These areas change only slightly between 1951 and 1954, due to deposition of debris on the western end of the first

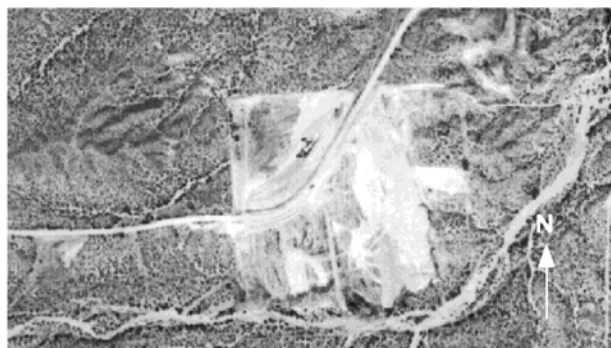
Fig. 11 (a) 1980 image of Las Cruces landfill. Note the tanker dumping liquid waste (just to left of road).

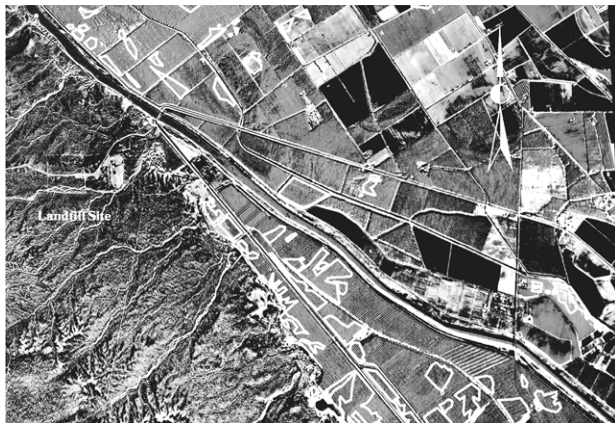
The change image was examined to detect areas of vegetation which showed initial stress, areas of advanced stress, and areas of dead or defoliated vegetation. All three levels of decay were delineated into polygons shown on Fig. 14.

Fig. 14. Image difference between 1984 and 1986. White blocky polygons delineate areas of vegetation stress. Original image scale is 1:58,000.

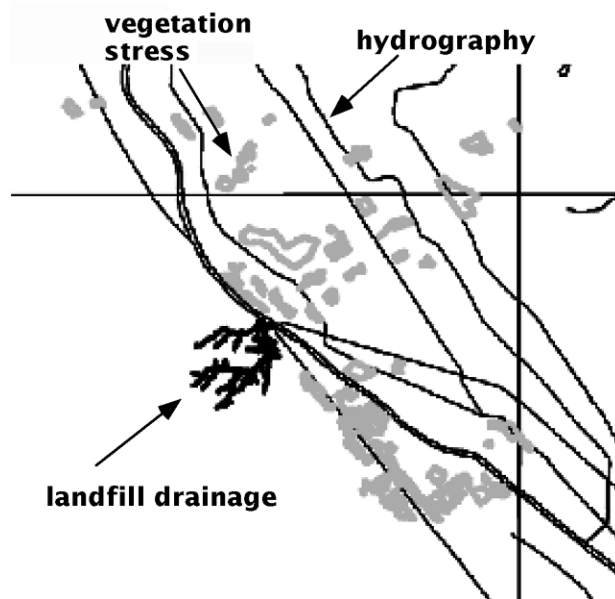
The boundaries of vegetation stress were merged with the hydrography vectors of the area. The merged vectors reveal trends in vegetation stress and local water flow in and around the landfill site. Figure 15 shows the merged vegetation stress and hydrography vectors. The vectors show that south and east from the landfill there are several areas of stressed vegetation. The stressed vegetation shows a migration tendency southward along the west side of the Santo Tomas Drain. This migration coincides with the shallow ground-water discharge patterns, which discharge to drains and ultimately flows into the Rio Grande. Further details of this study can be found in Lewis and Van Eeckhout, 1996.

Fig. 15. Hydrography vector merged with stressed vegetation. Landfill drainage is also shown.
